I've always done it this way!

A KC-135 Aircraft was being pressurized at ground level. The outflow valves which are used to regulate the pressure of the aircraft were capped off during a 5 year overhaul and never opened back up. The post-investigation revealed: that a civilian depot technician who, "had always done it that way," was using a homemade gauge, and no procedure.

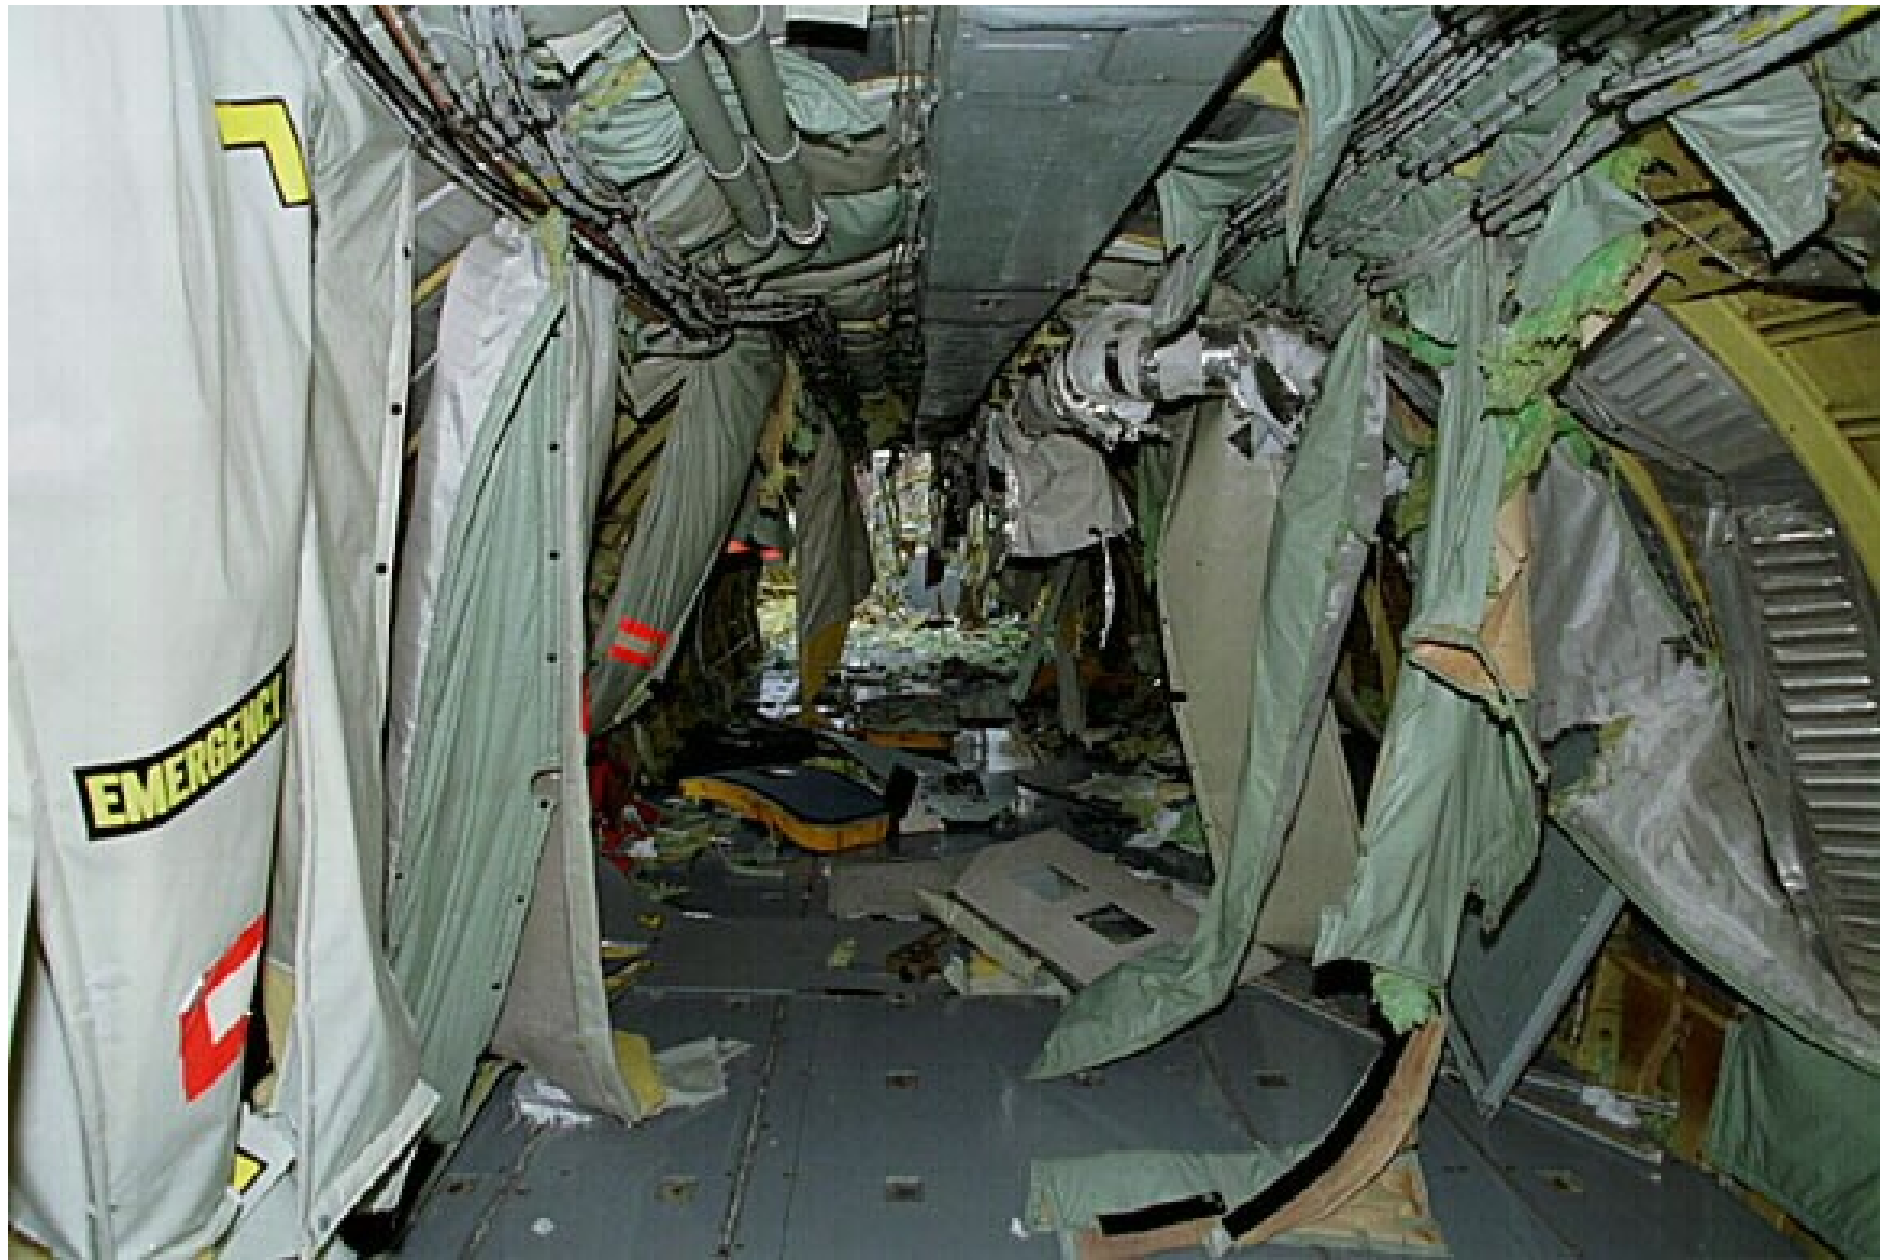
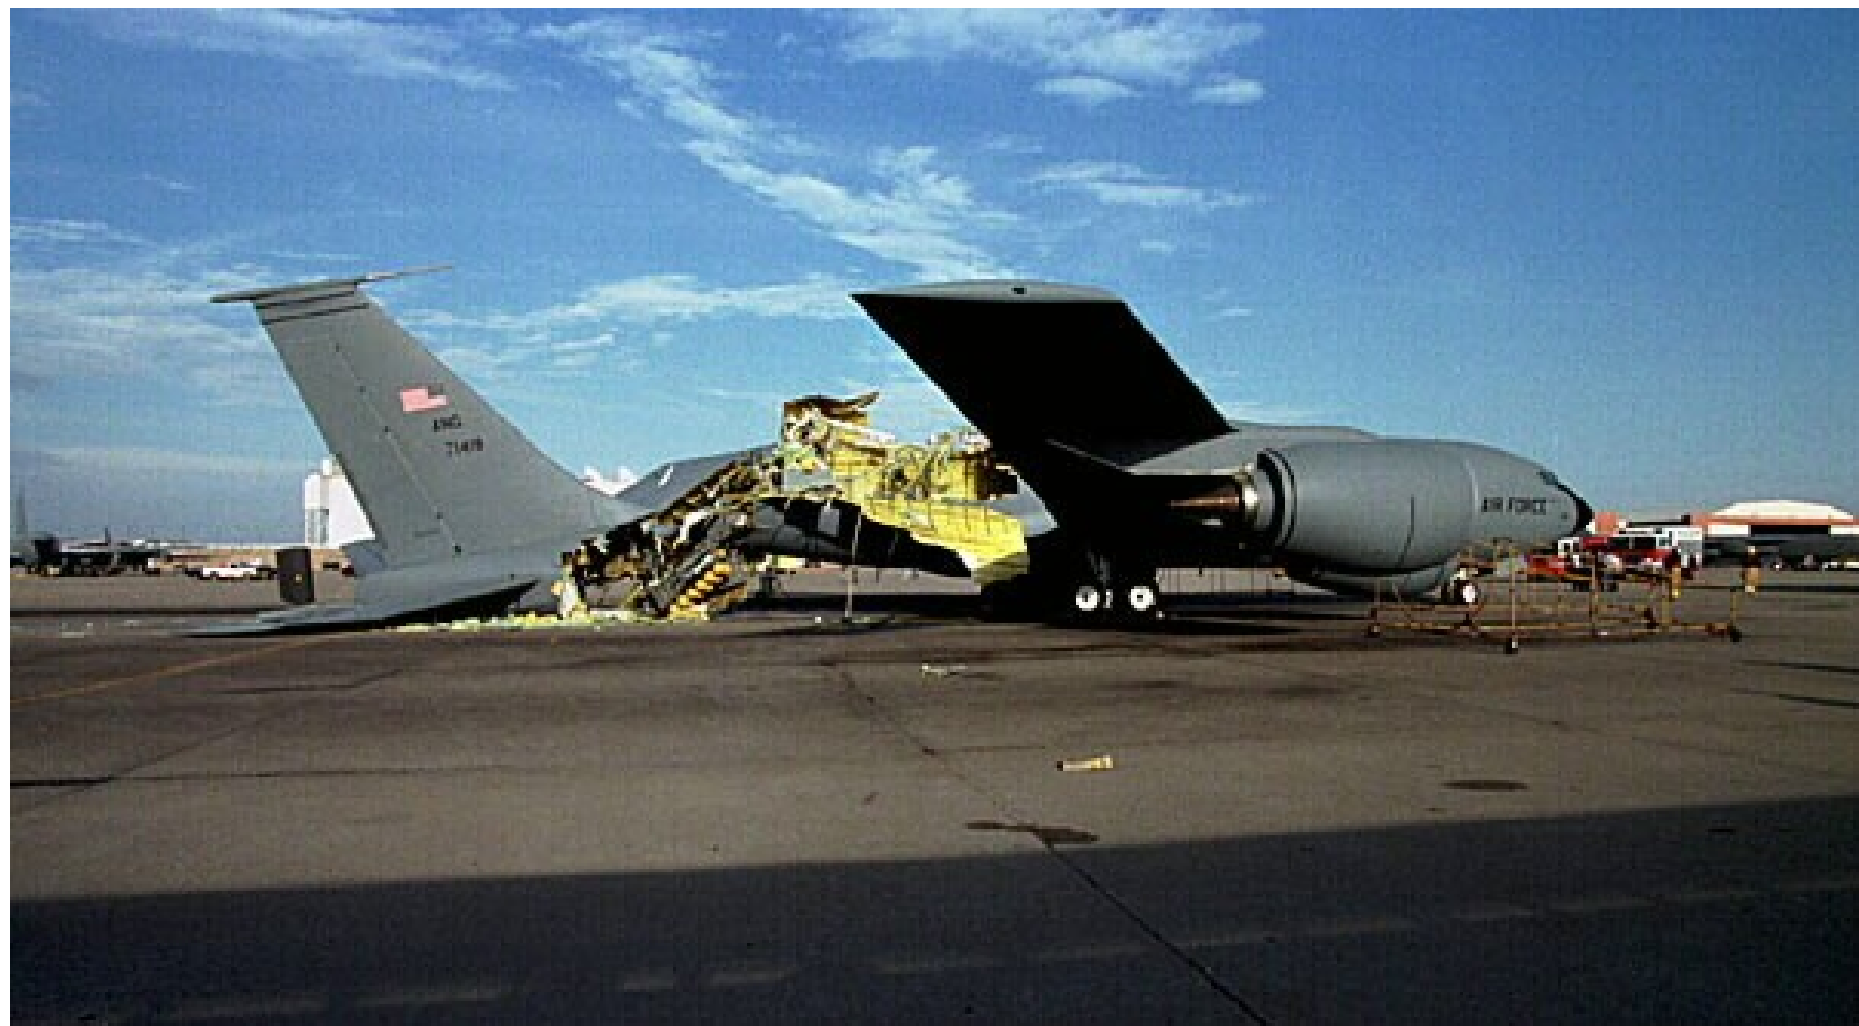
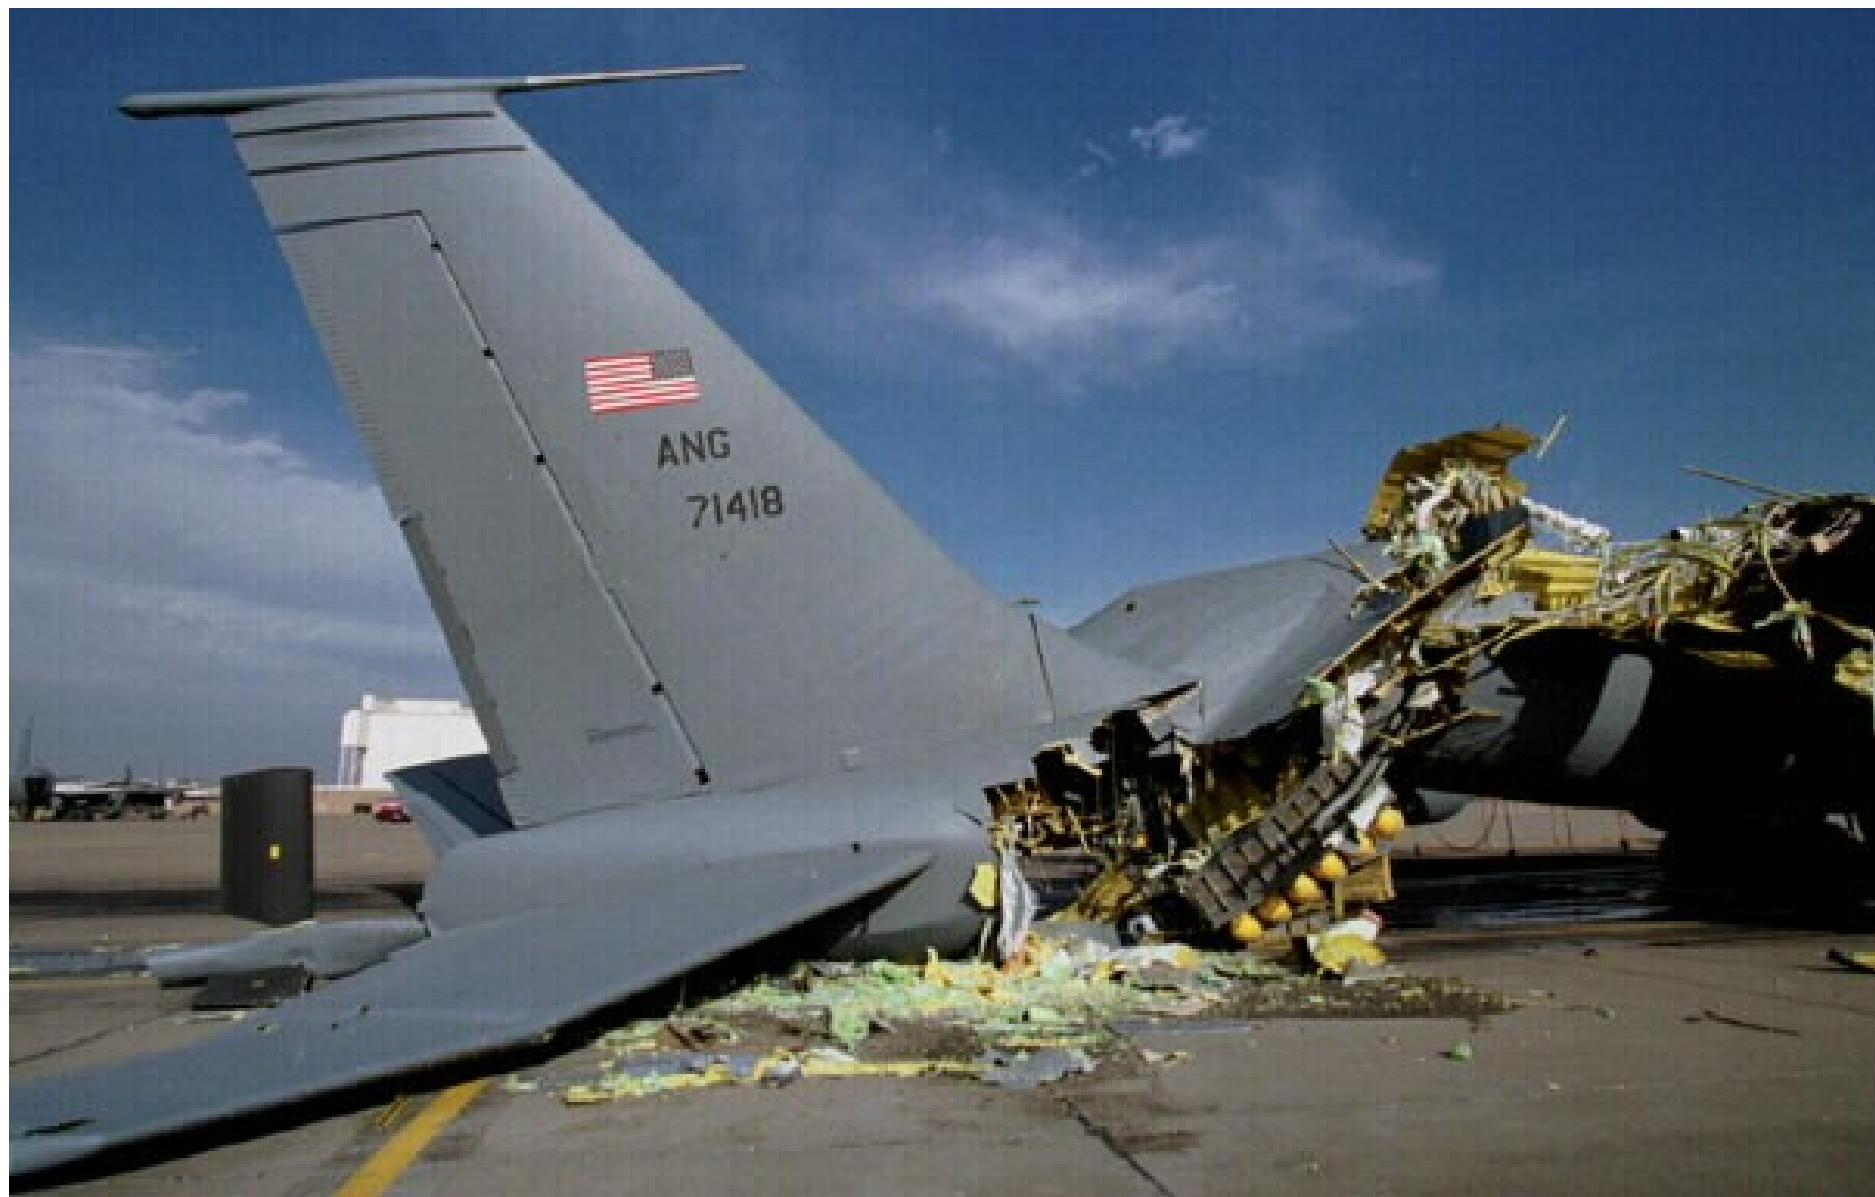
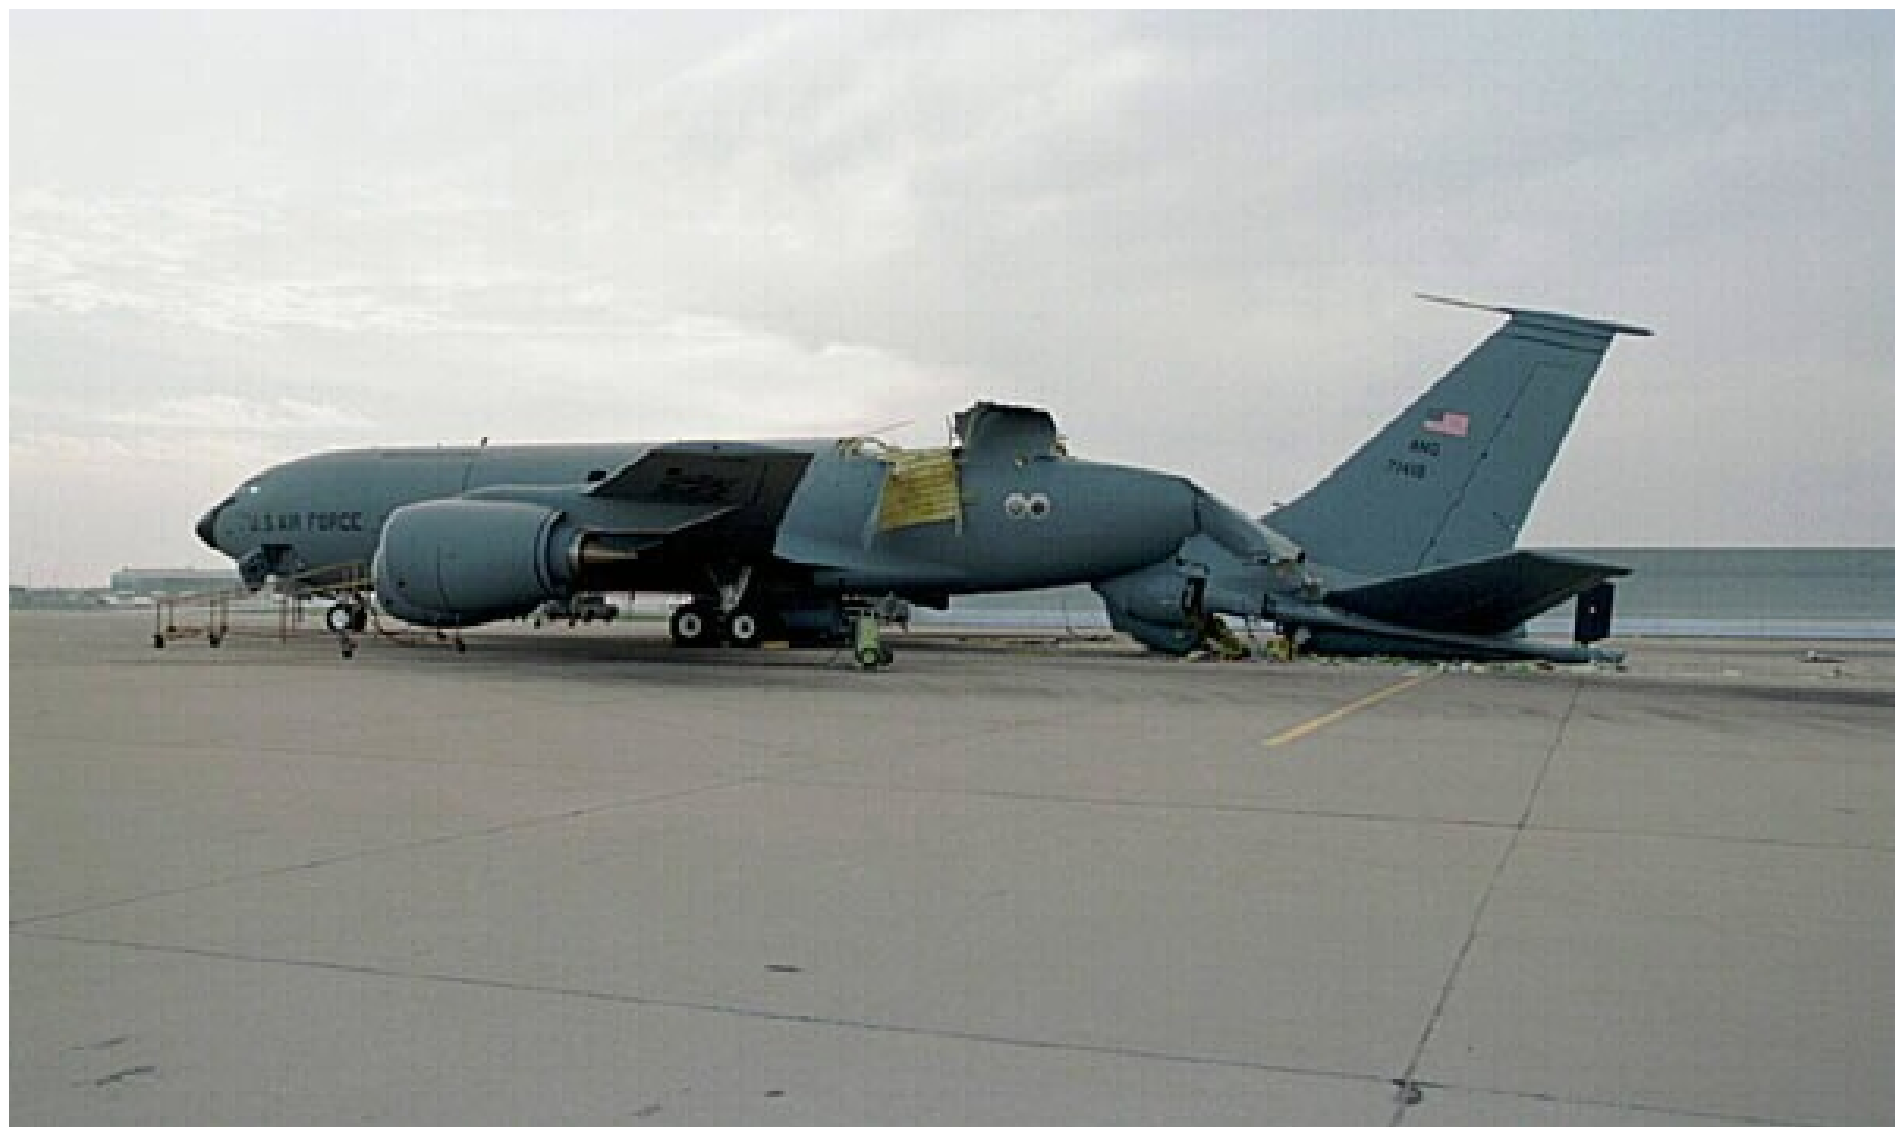
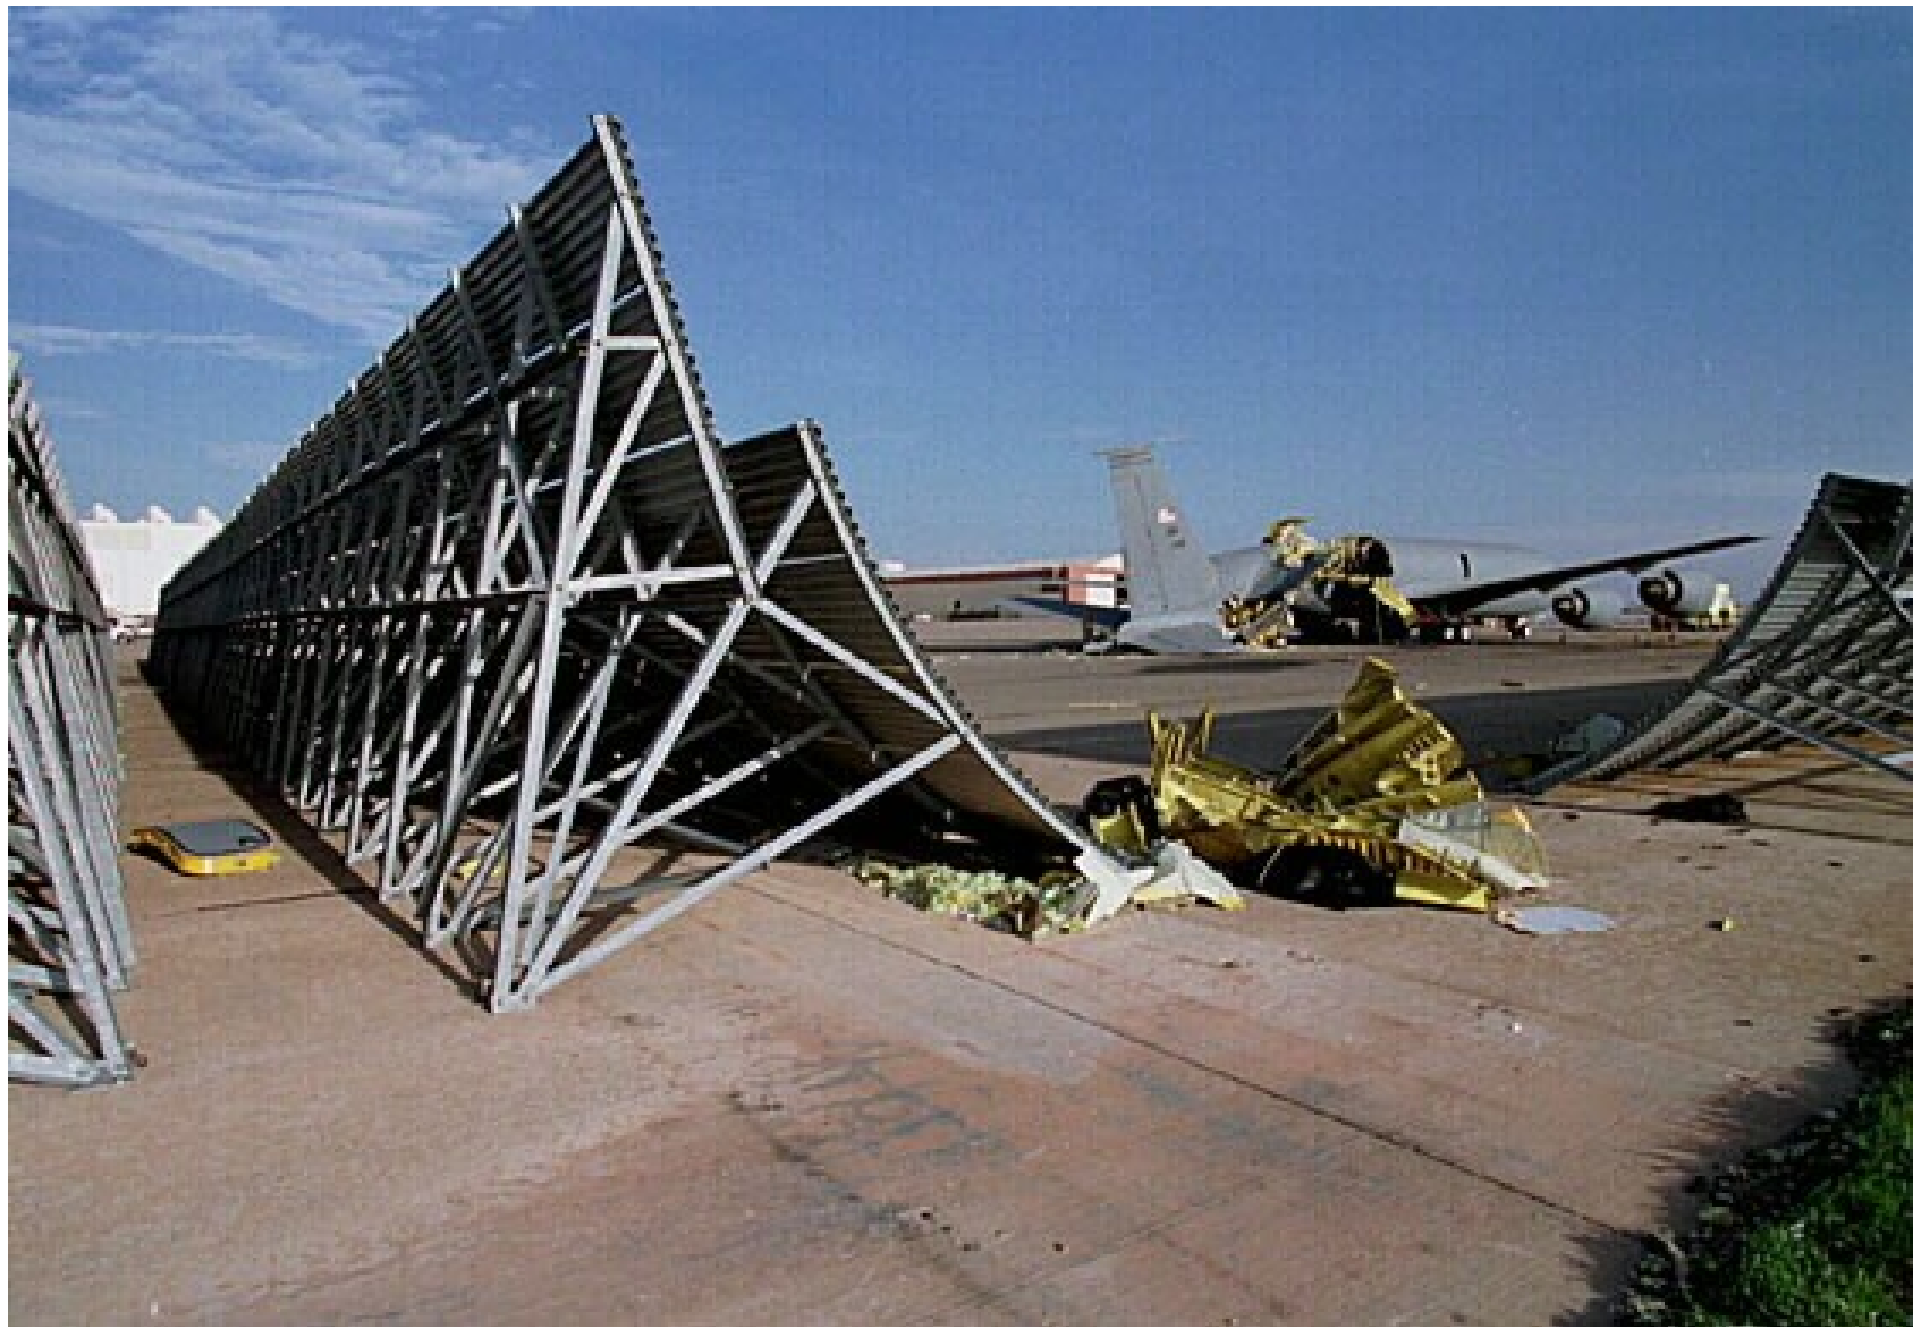
The technician's gauge didn't even have a max "peg" for the needle and so it was no surprise he missed it when the needle went around the gauge the first time. As the technician continued to pressurize the aircraft, and as the needle was on its second trip around the gauge the aircraft went "boom" - the rear hatch was blown over 70 yards away, behind a blast fence!

This was a good "Lessons Learned" for making sure we have trained people, who have the right tools, and who are following detailed procedures. And it should serve as a reminder that just because you've always done it that way, it does not make it the "right" way!
